CONDITION & MARINE RISK

File #: 1522933
Date: January 9, 2015
Vessel's Name: [Redacted]
Type: [Redacted]
Builder: [Redacted]
Power: Twin Gasoline
Year: 2006
Hull #: [Redacted]
Doc # / Reg #: * N/P
Surveyed by: [Redacted]
In Water: Yes
Hauled: Intermarine Ft. Lauderdale FL
Sea Trialed: Yes, ICW Hollywood, Florida
On: January 9, 2015

REPORT OF SURVEY

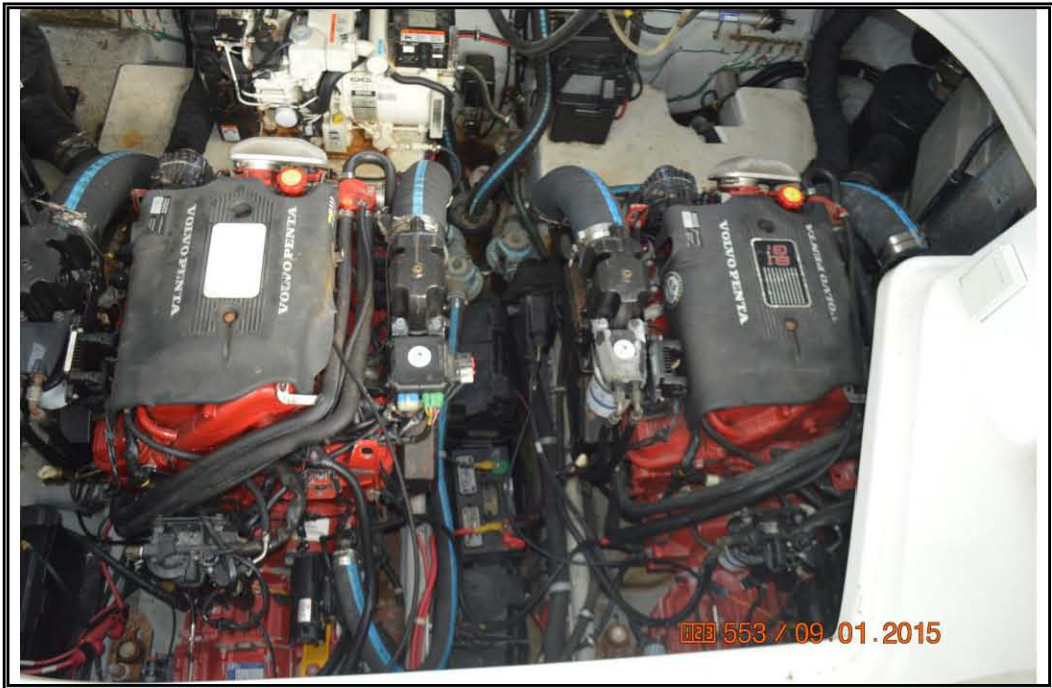
Picture No:	Ten
Description:	PORT AND STARBOARD MAIN ENGINES / ENGINE ROOM

28. Generator was hard to start but was eventually proved with a full load at sea trials however the Hz was low and requires adjustment.
29. Engine room overall shows corrosion and rust. Poorly maintained. Engine room deck drains plugged and water leaking into

30. Generator and pan rusty.
31. Sea trial was not completed as the main engines were running poorly. Port main engine would not run more than 3000 RPM at WOT, Specifications are 4600 RPM.

32. Main engines show significant corrosion / rust overall, slight water leaks at manifold to risers. Tighten and clean as required.
33. It is recommended that a Volvo engineer be engaged to thoroughly inspect the main engines and transmissions, tune as necessary, change all oils and filters and conduct a compression test, as he so advises.
